Safety Alert

Electrical Incident – Exposed Live Parts when Resetting Bell Control Units

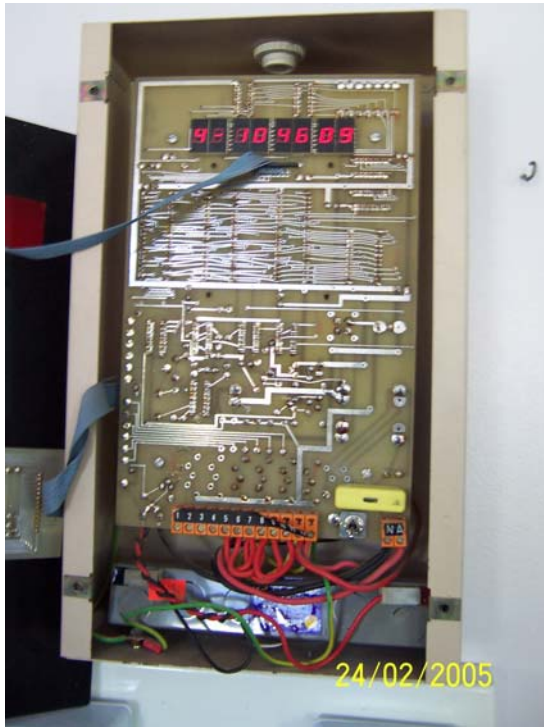
Staff and others are at risk of electric shock when removing the cover of the Simplex 2399 Bell Control Unit. Live terminals are exposed when the cover of the unit is removed to reset the device. The risk of touching the live terminals and receiving an electric shock is significant.

1. Prohibit removal of covers of bell control units (Simplex or similar)
2. Place signage on the cover to advise that it should not be removed by staff
3. Inform staff of the risks and reasons for this safety precaution
4. Engage a technician to assess and repair problems with the bell system
