Safety Alert

Electrical Incident - UV Exposure Hazard

High Intensity Discharge Lamps

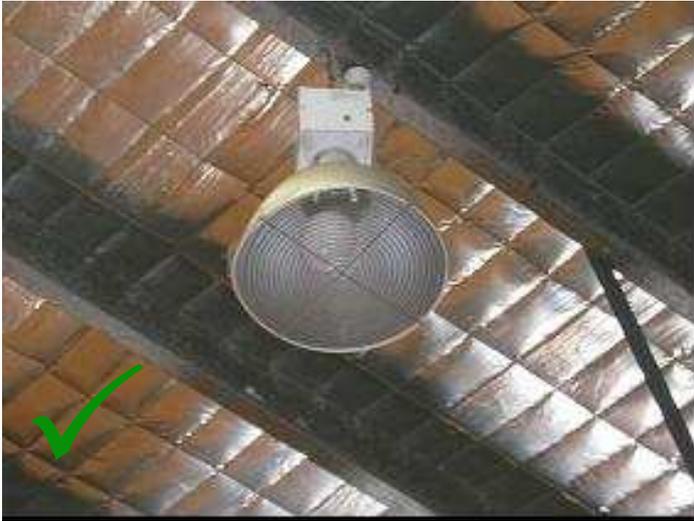
HID (High Intensity Discharge) lamps are typically used in gymnasiums, multi-purpose centres and indoor sports areas. The lamps in these light fittings have an inner quartz tube, enclosed by an outer glass envelope that is designed to filter out UV radiation.

A group of people recently received UV burns to their skin and eyes (requiring hospital treatment) when damaged HID lighting was operated at a school. There is also the risk of dangerous glass shards falling on persons below if a protective grille is not present and a breakage occurs.

Potential hazards may exist when high bay lighting of this type is not securely covered by a protective wire grille, or is operated when the protective glass envelope is damaged:

- physical hazard - if a protective grille is not present and a lamp's outer UV protective glass envelope shatters (e.g. through a ball strike), glass shards may fall on persons/students below;
- health concern - if the lamp's outer UV protective glass envelope breaks and the inner arc chamber of the lamp continues to operate, possible sunburn and eye damage may occur.

- 1) Staff should visually inspect HID lighting from the ground prior to use (while turned off) to ensure that protective grilles are in place and the casings are not deformed from ball strikes etc.

- 2) Damaged lights should be turned off until repairs are carried out by a licensed electrical contractor. School staff are not licensed to perform work near live electrical parts on any item of electrical equipment. Signage should be erected by the light switch to advise that lights should not be operated.

- 3) When replacement occurs, request lamps with a Teflon coating to ensure that shattered glass will not become a potential future hazard in the event of breakage.

- 5) Activities in these type of facilities should be supervised at all times to ensure that damage to high bay light fittings is not deliberately carried out (e.g. kicking of balls where not permitted etc).
