Ensure a smooth term commencement after contractor holiday works

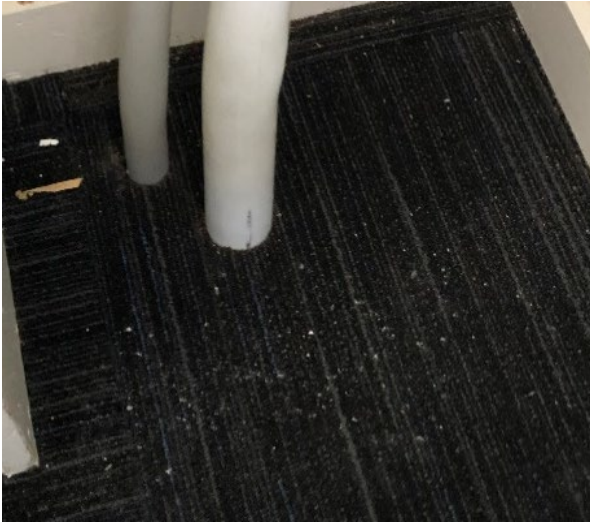
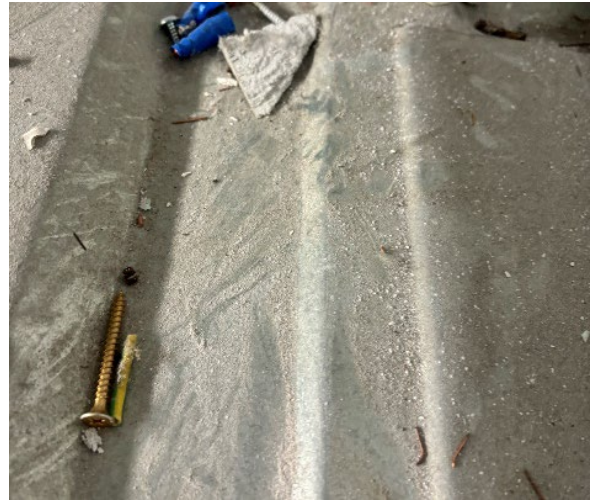
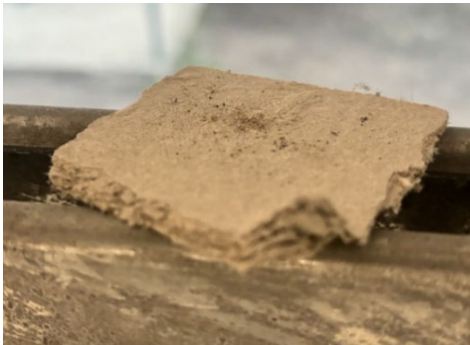
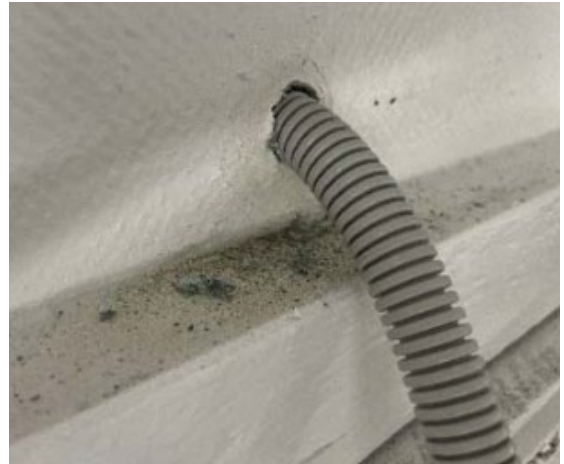
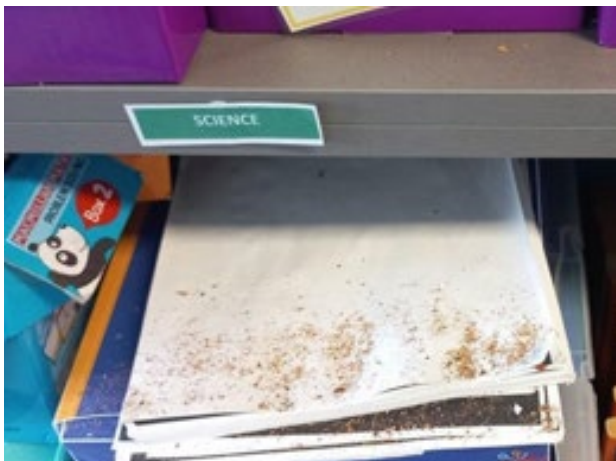
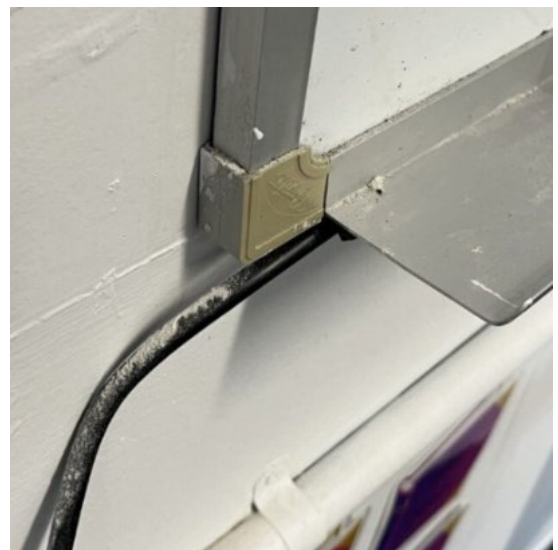
Exposed Asbestos Containing Material (ACM) dust or debris is not always obvious, here are some examples of what to look for:

- check contractor has signed off the ‘AFTER THE WORK IS COMPLETED’ section of the WAAP to confirm works have been completed and the area is safe for reoccupation
- inspect the work area and surrounding area for visible signs of dust or debris from the works or unsealed penetrations
- liaise with Infrastructure Safety immediately if there are concerns about contractors’ clean-up efforts.

Note: Departmental staff (including cleaners) are prohibited from conducting cleaning of dust/debris following any contracted works.
