Safety Alert

Asbestos containing material found in work benches

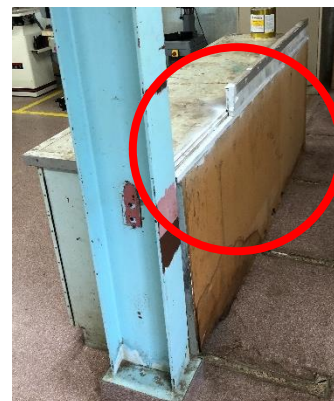
Recently, an incident that released ACM occurred at a school. A piece of furniture in a technology workshop was being modified. ACM contained and hidden within the furniture was released when staff cut into the panelling. Once this release was identified the room was closed and cleaned. Staff and students involved in the incident were informed of the possible exposure and the incident recorded.

- identify any similar objects (furniture built over 20 years ago) and either remove them from the school or mark them as possible ACM and ensure they are treated as ACM
- ensure all possible ACM is recorded in Asbestos Registers (within [BEMIR](#))
- seek explicit written permission of the school principal for modification of any school equipment
